PETERSEN RANCH BANK ENABLING INSTRUMENT REVIEW OF
U.S. ARMY CORPS OF ENGINEERS COMMENTS

May 4, 2015

Project: Petersen Ranch Mitigation Bank [USACE: SPL-2012-00669, CDFW: 1798-2013-04-R5]

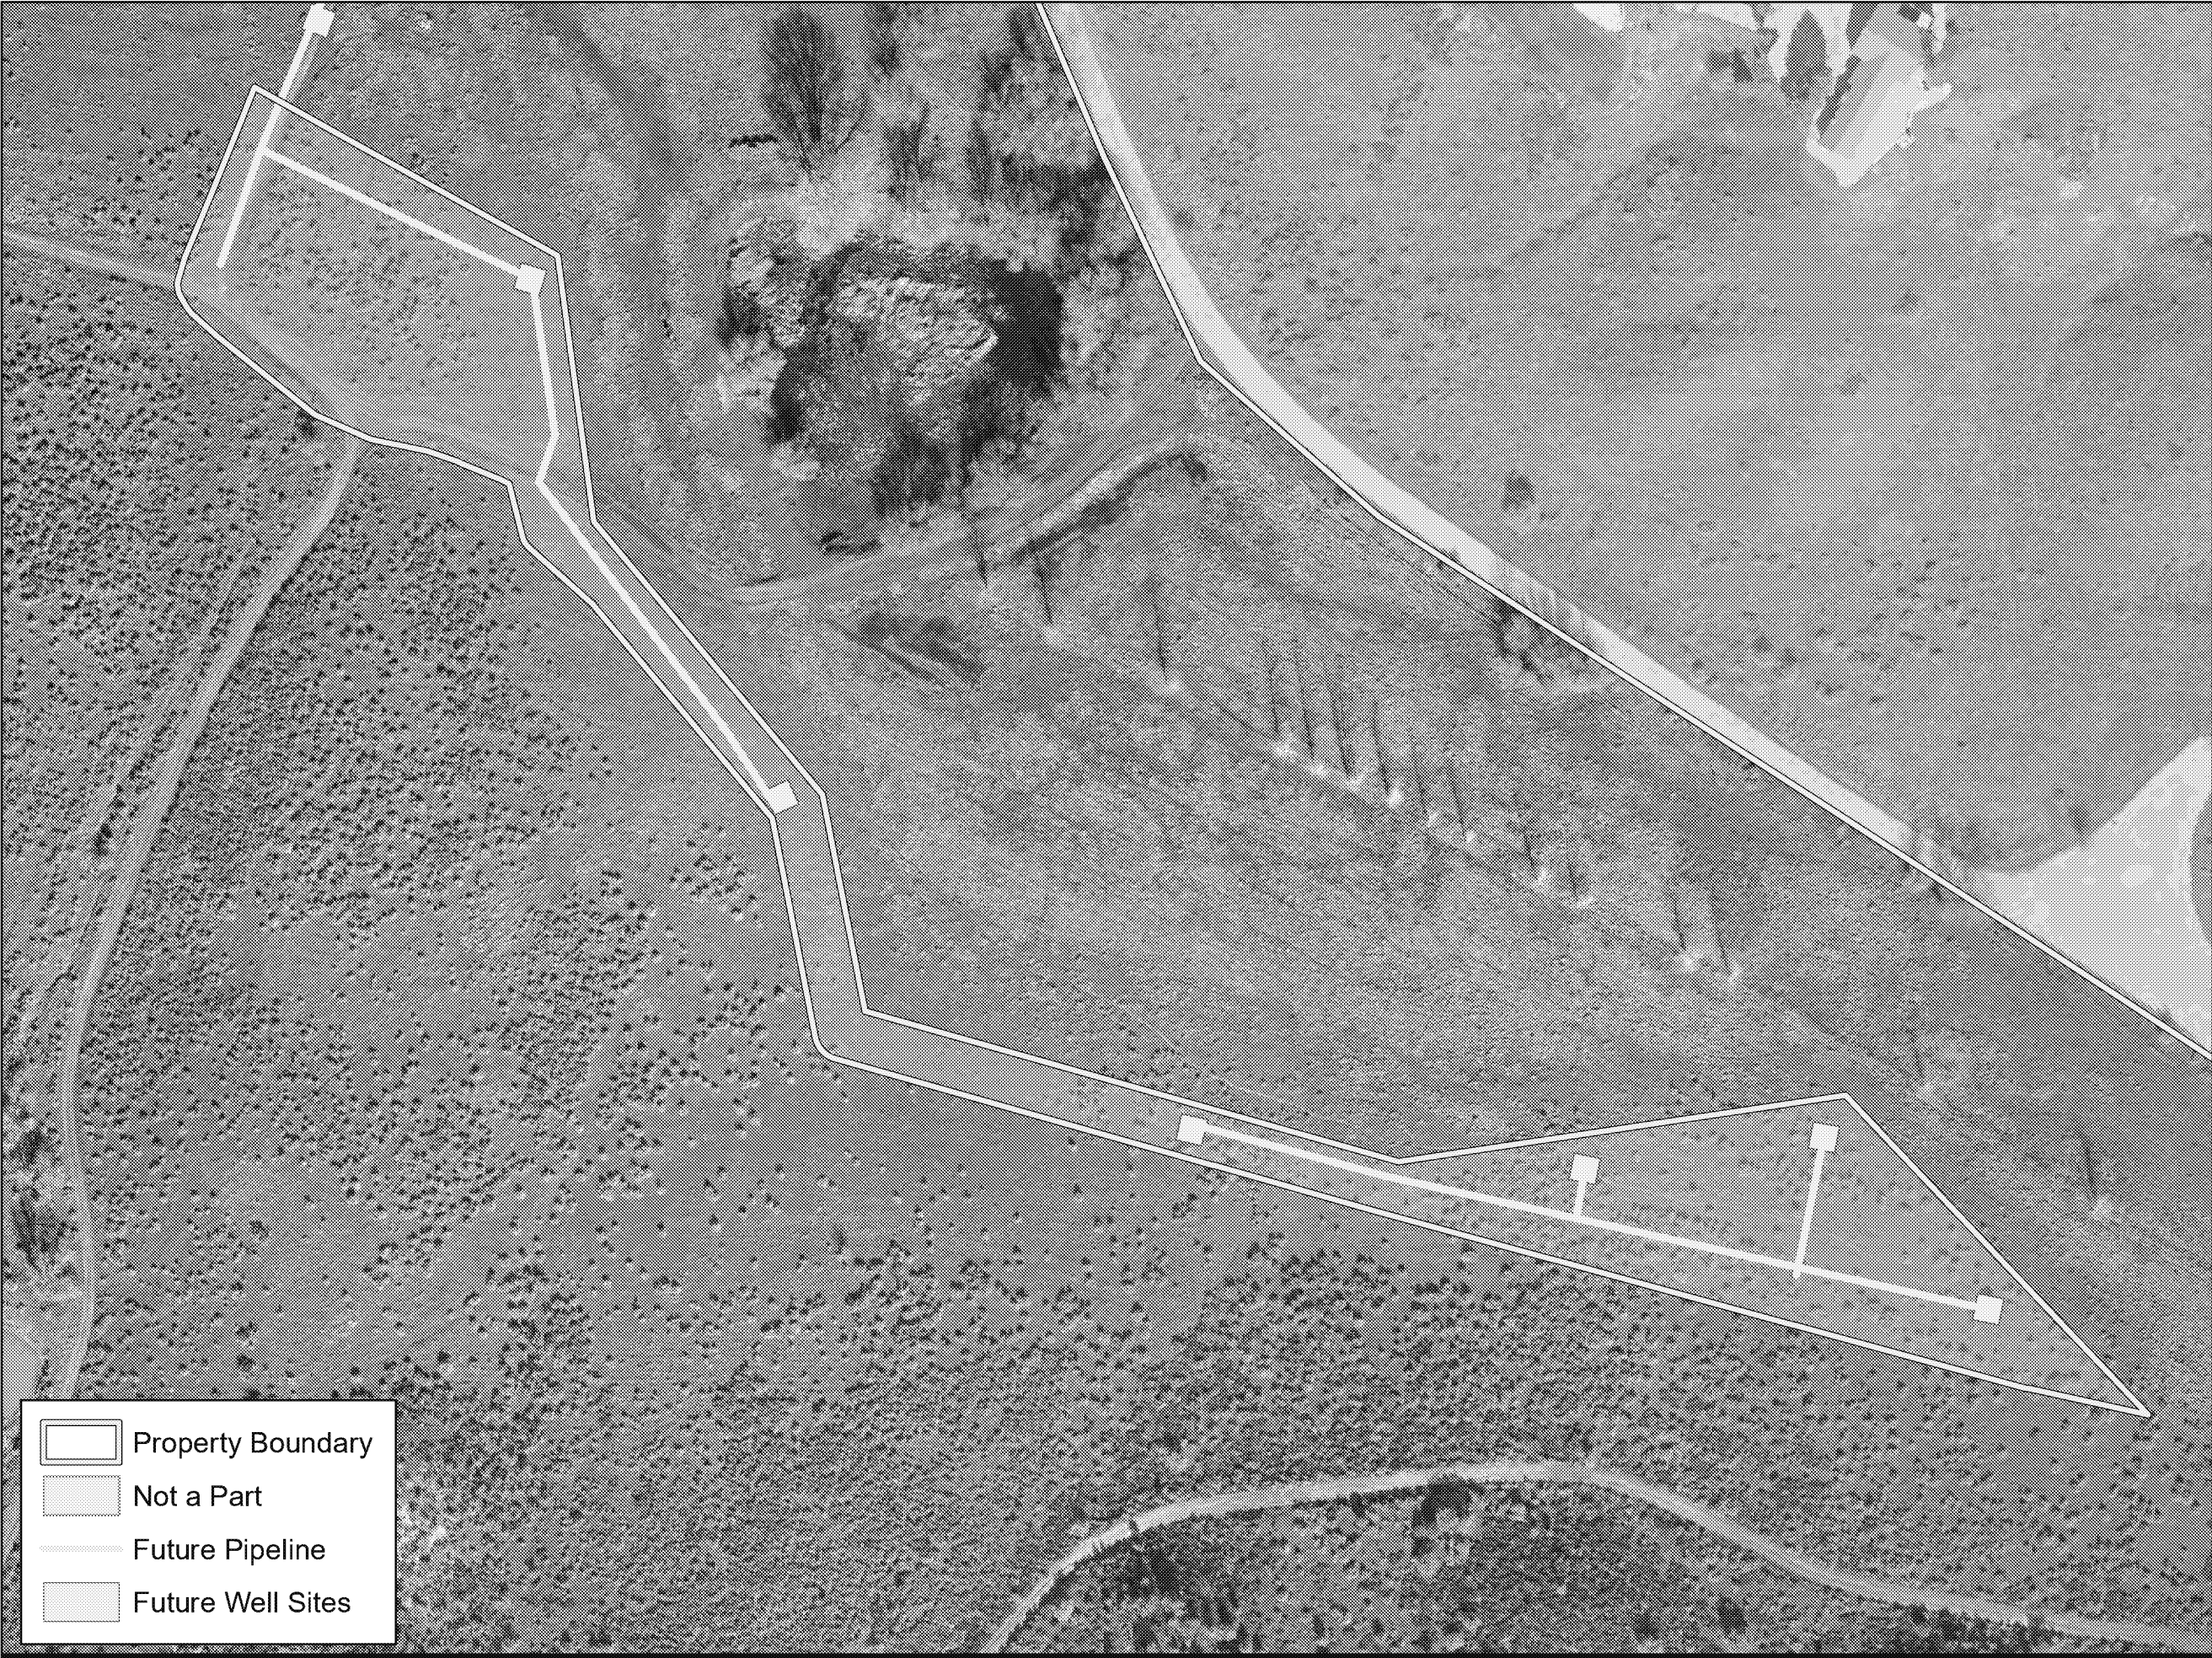
Future Well and
Pipeline Sites

Property Boundary

Not a Part

Future Pipeline

Future Well Sites
